**Emergency Response Report**

Hydrogen Chloride - MGP, Atchison, Kansas

### EMERGENCY RESPONSE REPORT

### HYDROGEN CHLORIDE – MGP, ATCHISON, KANSAS

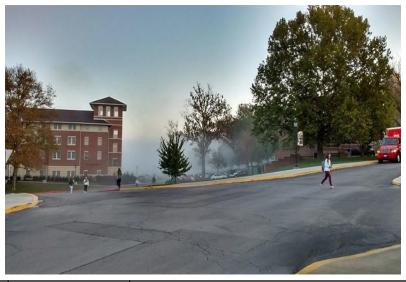
TETRA TECH PROJECT NO.	PHOTO DESCRIPTION	This photograph shows students evacuating Benedictine College. Students from the high school, middle schools, and alternative schools were also evacuated.	6
X9025.14.0001.031	CLIENT	EPA Region 7	Date
Direction: Unknown	PHOTO SOURCE	RT.com	10/21/16

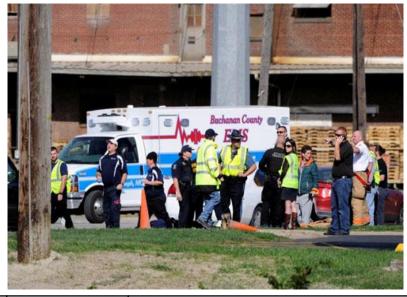
TETRA TECH PROJECT NO.	PHOTO DESCRIPTION	This photograph shows Buchanan County Emergency Medical Service staff and other officials collaborating in an evacuated area.	8
X9025.14.0001.031	CLIENT	EPA Region 7	Date
Direction: Unknown	PHOTO SOURCE	EMTV	10/21/16

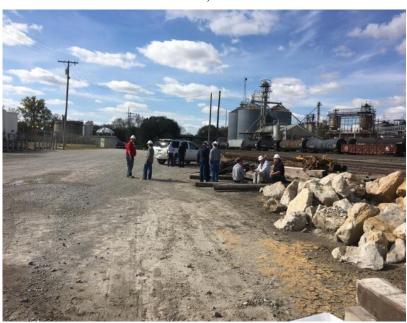
_
TETRA TECH PROJECT NO. X9025.14.0001.031	PHOTO DESCRIPTION	This photograph shows an EPA Superfund Technical Assessment and Response Team (START) contractor interviewing an MGP supervisor regarding the incident. EPA and START arrived on scene at about 1300 hours and began air monitoring activities using MultiRAE detectors equipped with chlorine sensors.	9
	CLIENT	EPA Region 7	Date
Direction: West	PHOTO SOURCE	N. Wiederholt (START)	10/21/16

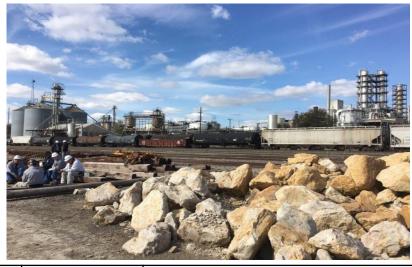
TETRA TECH PROJECT NO.	PHOTO DESCRIPTION	This photograph shows evacuated MGP employees and the production and storage facility northwest of the incident site.	10
X9025.14.0001.031	CLIENT	EPA Region 7	Date
Direction: Northwest	PHOTO SOURCE	N. Wiederholt (START)	10/21/16

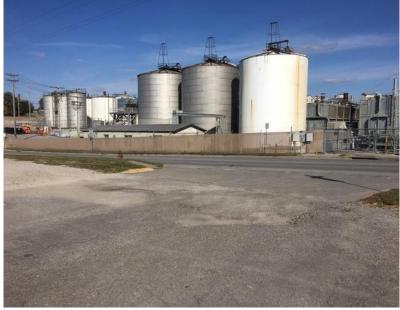
TETRA TECH PROJECT NO.	PHOTO DESCRIPTION	This photograph was taken from the west side of the MGP facility and shows some of the storage tanks.	12
X9025.14.0001.031	CLIENT	EPA Region 7	Date
Direction: Northeast	PHOTO SOURCE	N. Wiederholt (START)	10/21/16

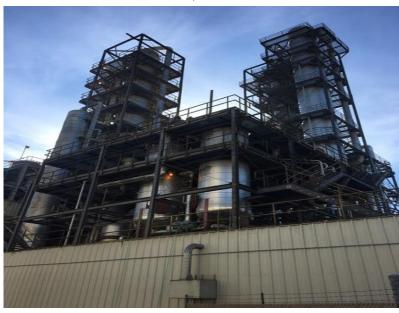
TETRA TECH PROJECT NO.	PHOTO DESCRIPTION	This photograph was taken from air monitoring location MR8 and shows some of the facility's emission stacks.	13
X9025.14.0001.031	CLIENT	EPA Region 7	Date
Direction: Southwest	PHOTO SOURCE	N. Wiederholt (START)	10/21/16

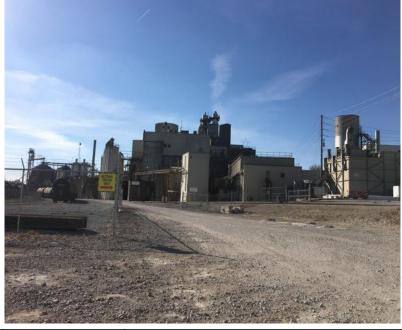
TETRA TECH PROJECT NO.	PHOTO DESCRIPTION	This photograph was taken from air monitoring location MR9 and shows the truck parking and loading entrance.	14
X9025.14.0001.031	CLIENT	EPA Region 7	Date
Direction: West	PHOTO SOURCE	N. Wiederholt (START)	10/21/16
